Master Home Inspectors of Texas, LLC

TREC REI 7-6 (MHITX)

# PROPERTY INSPECTION REPORT FORM

123 Sample Street, Demo City, ST 12345

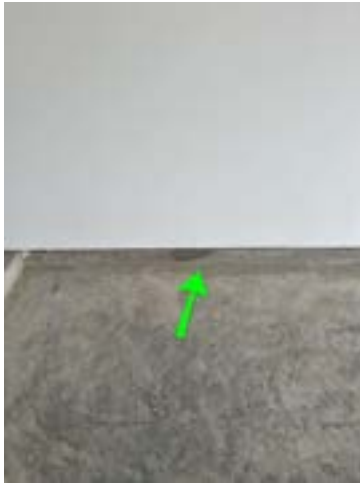
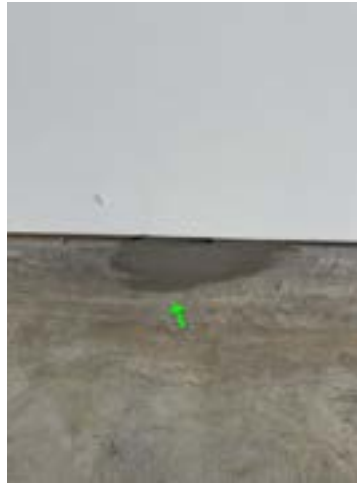
Evidence of repairs was observed in one or more locations of the slab foundation at the time of the inspection. This is for your information.

The inspector recommends speaking to the builder for further evaluation and correction by a foundation specialist.

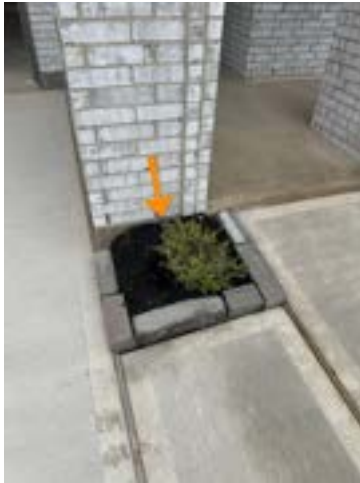
High soil/mulch was observed at the time of the inspection. These areas may be more prone to moisture accumulation/ intrusion and wood destroying insects. There should be at least 6 to 8 inches of clearance between the exterior siding and ground. This is for your information.

Front of home, foundation, high soil/ mulch

The inspector recommends speaking to the builder for further evaluation and correction by a qualified landscaper to protect from moisture and/ or wood destroying insects.

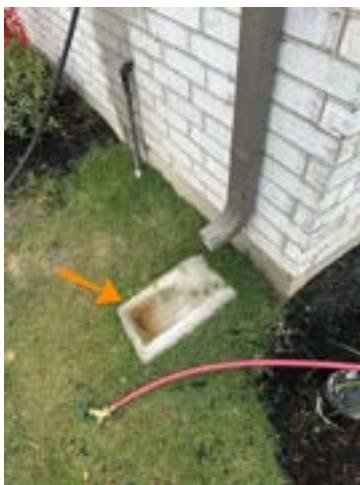
Insufficient install was observed at one or more gutter downspout splash boxes at the time of the inspection. There should be no standing water in the splash boxes.

Front of home, splash box, insufficient

The inspector recommends speaking to the builder to have the splash boxes installed to promote efficient drainage.

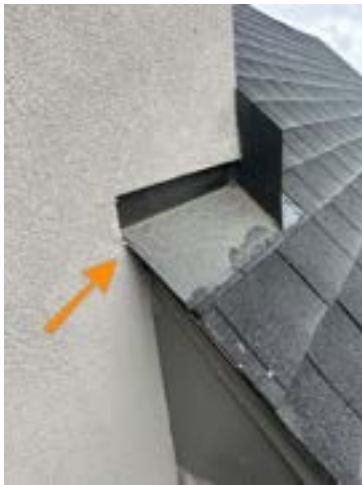
Insufficient kick-out flashing was observed at multiple roof to wall connections at the time of the inspection. The inspector recommends a professional roofer install kick out flashing to protect the siding and to protect from moisture intrusion.

Front of home, roof to wall connection, insufficient kick out flashing

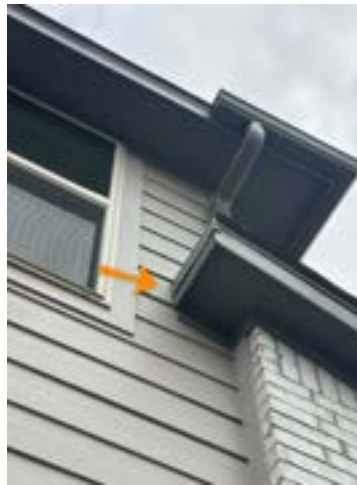
Right side of home, roof to wall connection, insufficient kick out flashing

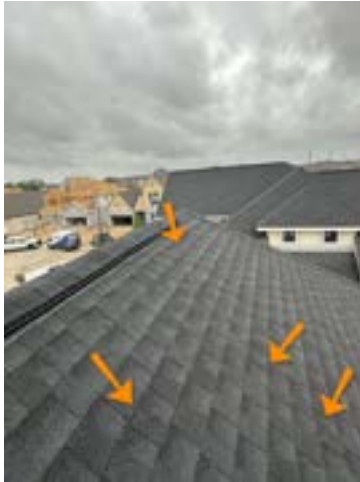
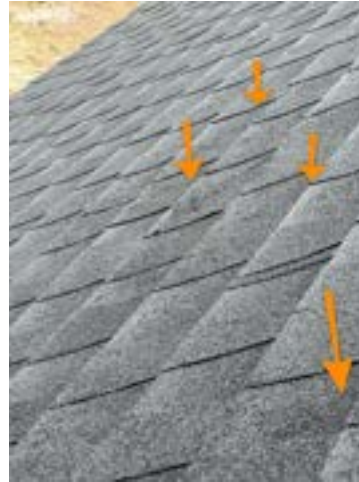
Scarring/ damage was observed on the shingles at the time of the inspection. This may decrease the service life of the roof covering materials.

Roof, shingles, excessive scarring

The inspector recommends speaking to the builder for further evaluation and

correction by a roofing contractor.

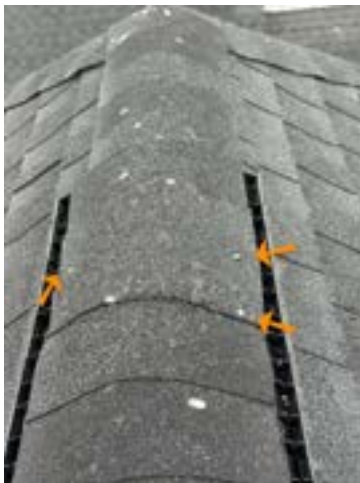
Exposed nail heads were observed at the time of the inspection. Nails heads should be properly covered/ sealed to protect from moisture intrusion.

Roof, ridge cap, exposed nails

The inspector recommends speaking to the builder for further evaluation and correction by a roofing contractor.

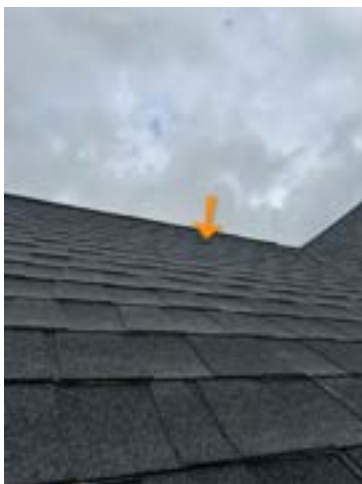
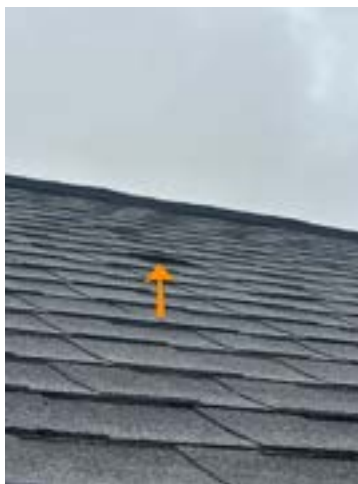
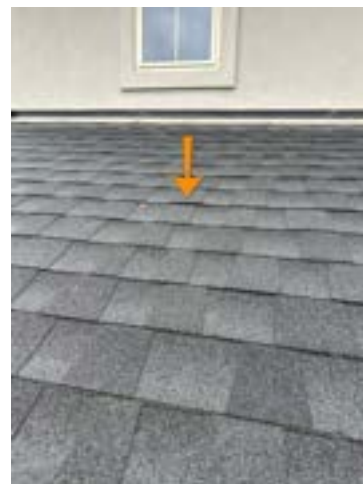
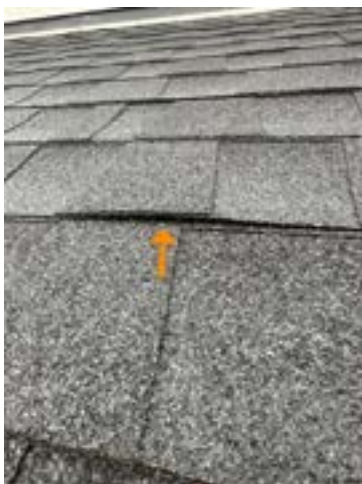
Loose/ uplifted shingles were observed in one or more areas of the roof at the time of the inspection.

Roof, shingles. loose/ uplifted

The inspector recommends speaking to the builder for further evaluation and correction to protect from wind driven rain and moisture accumulation under the loose shingles.

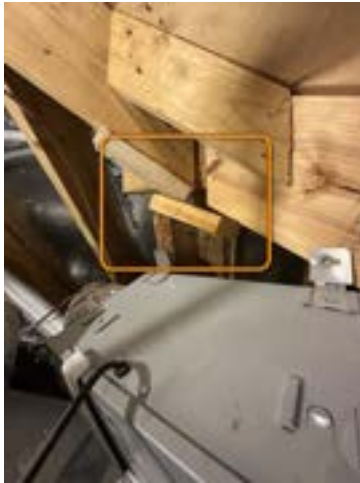
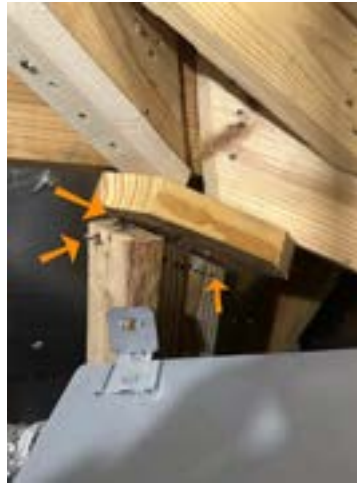
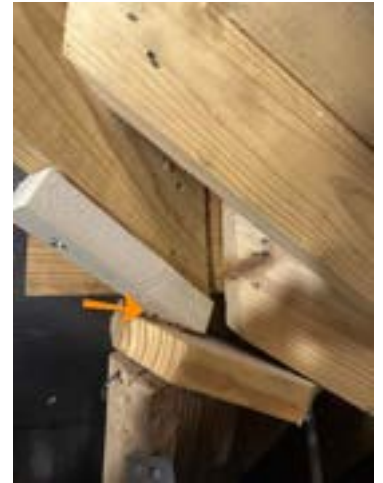
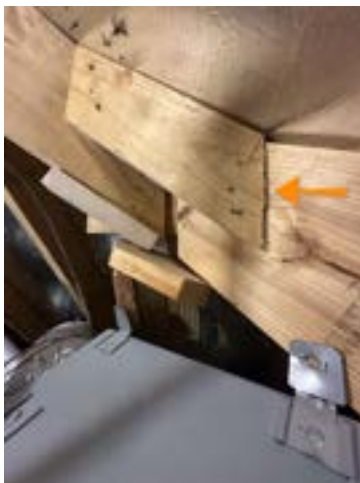
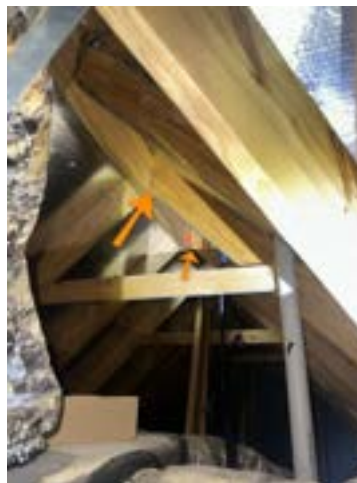
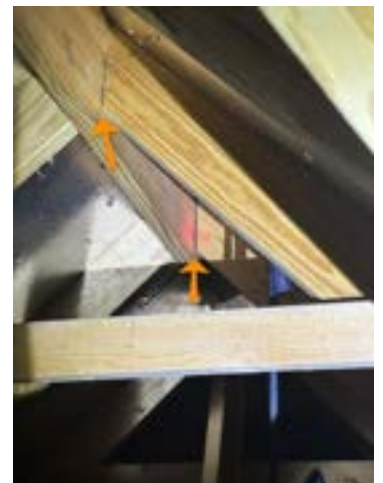
Evidence of movement in structural members was observed at the time of the inspection. The inspector is unable to determine when the movement occurred. The evidence of movement observed is listed but not limited to the following: (1) Twisting or rotating of structural members. (2) Separation at structural members connections. (3) Splitting of wood structural members.

Attic, structural members, separation at connections

The inspector recommends further evaluation by a structural engineer to determine the severity.

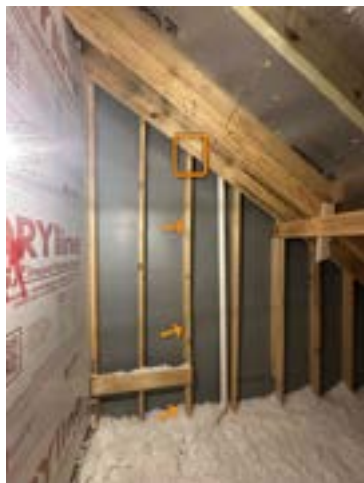
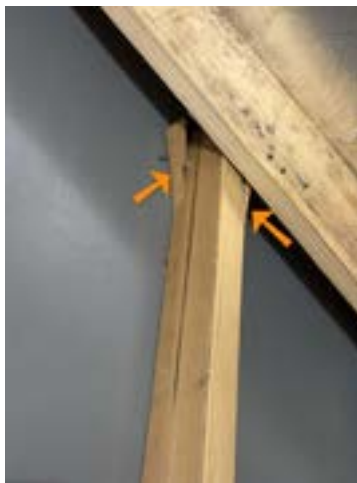
Attic, structural members, twisting & wood splitting

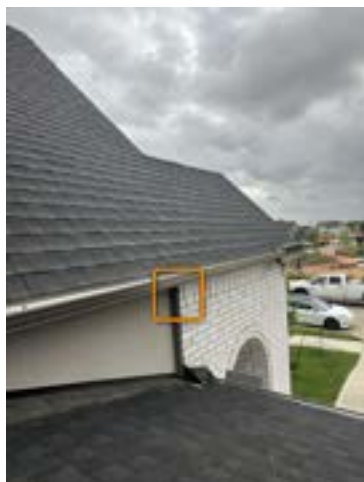
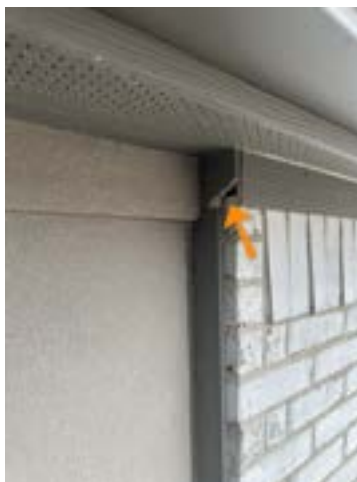
One or more damaged fascia boards were observed at the time of the inspection.

Front of home, fascia board, damaged/ hole

The inspector recommends speaking to the builder for replacement by a qualified contractor.

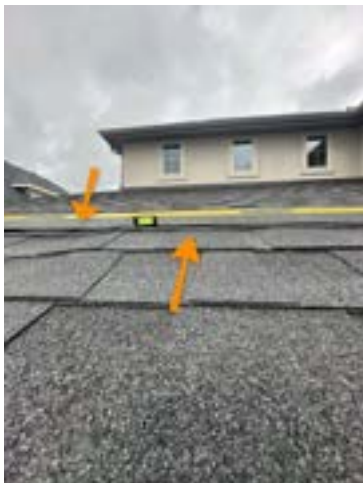
Waved/ uneven roof decking was observed at the time of the inspection.

Front of home, roof decking,  
uneven

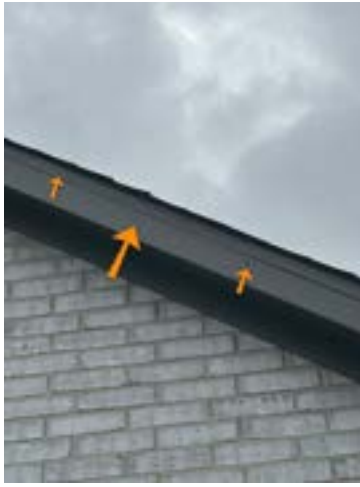
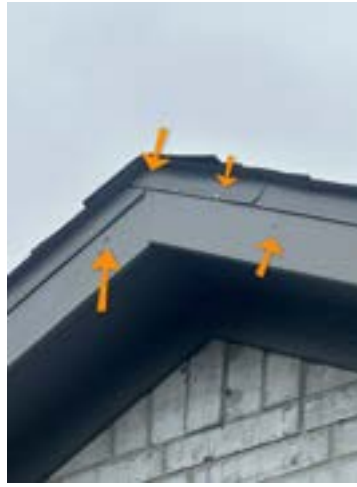
Nail pops and exposed nails were observed in one or more fascia boards at the time of the inspection. In the inspector's opinion, nail pops may be an indicator of over-driven or under-driven nails and may decrease the service life of the fascia board.

Back of home, fascia boards, nails pops & exposed nails

The inspector recommends speaking to the builder for replacement by a qualified contractor.

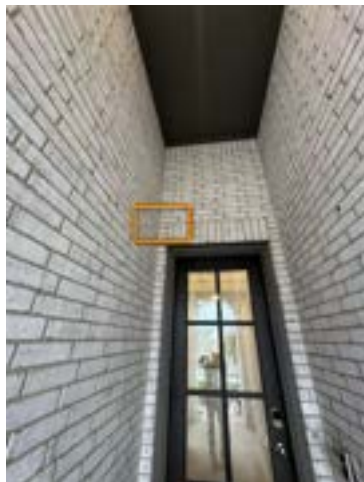
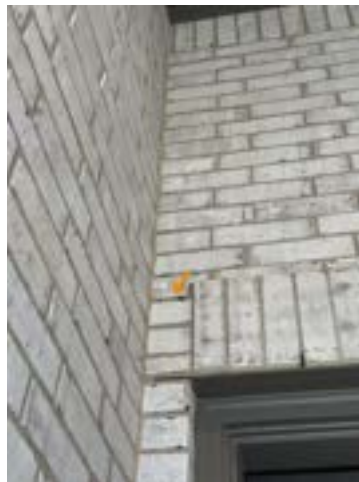
Gaps were observed in one or more areas of the brick and stone sidings mortar joints at the time of the inspection. In the inspectors opinion, this is not standard for a home this age and may decrease the service life of the siding materials over an extended period of time. This is for your information.

Front of home, brick mortar, gaps      Front of home, brick mortar, gaps

The inspector recommends speaking with the builder to have a qualified siding contractor further evaluate the siding and make corrections where needed to protect from moisture intrusion.

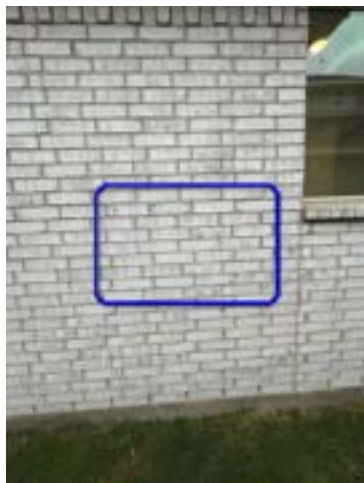
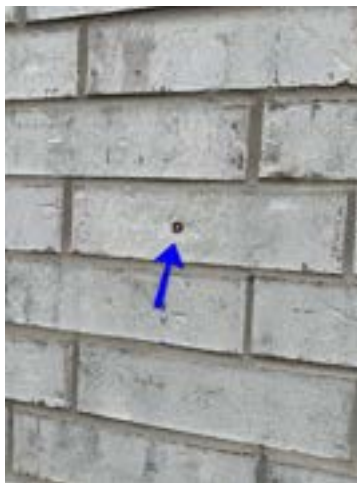
Spalling was observed on the brick siding in one or more locations at the time of the inspection. Spalling can occur if an excess amount of moisture vapor wicks through the brick siding over an extended period of time.

Right of home, brick siding,  
spalling

The inspector recommends monitoring as part of routine maintenance. If you notice new or worsening spalling the inspector recommends speaking to the builder for further evaluation by a brick siding specialist to determine if immediate action is required.

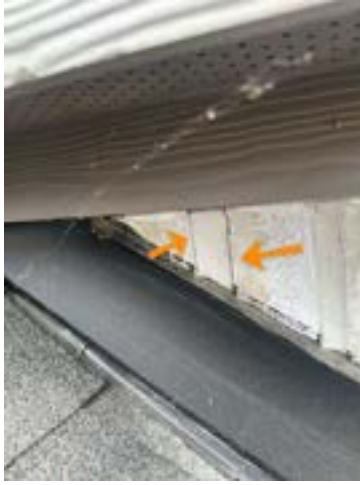
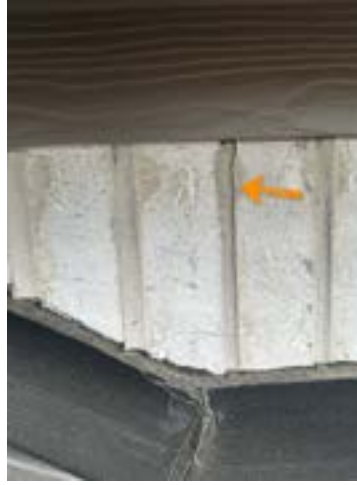
Cracks were observed in one or more areas of the brick sidings mortar joints at the time of the inspection. In the inspectors opinion, this is not standard for a home this age and may decrease the service life of the siding materials over an extended period of time. These areas are also more prone to moisture intrusion. This is for your information.

Back of home, brick siding, mortar joint cracked

The inspector recommends speaking with the builder to have a qualified siding contractor further evaluate the siding and make corrections where needed to protect from moisture intrusion.

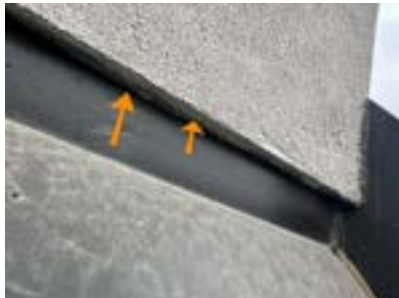
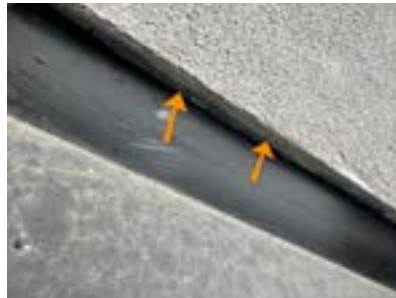
Covered weep holes were observed at the stucco siding at the time of the inspection. Weep holes are intended to allow incidental moisture to drain from behind the stucco system. When these openings are blocked or covered, moisture can become trapped, which may lead to concealed water intrusion, material deterioration, and related damage over time.

Stucco siding, weep holes, covered

The inspector recommends correction by the builder or a qualified contractor to expose and restore the weep holes to proper function and to verify the stucco drainage details were installed correctly.

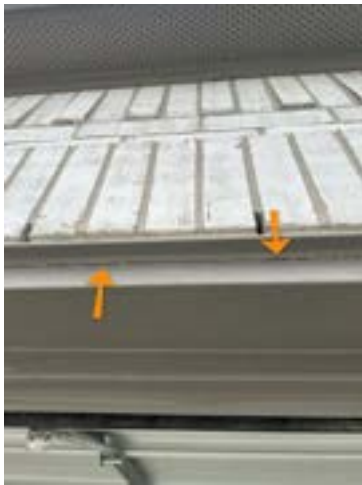
Separation was observed in the caulk/ sealant between the garage door header trim and the lintel at the time of the inspection. The inspector recommends speaking to the builder for further evaluation and correction to protect form moisture intrusion and damage over time.

Garage door header trim and lintel,  
caulk/ sealant separated

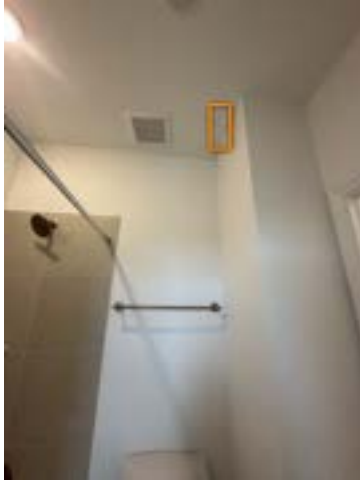
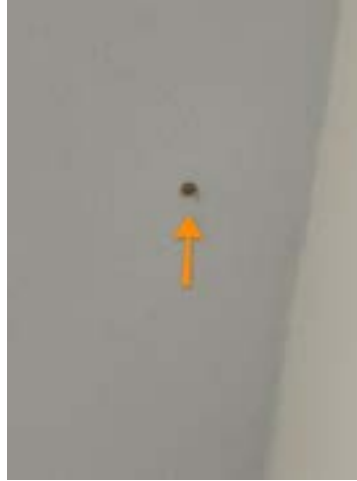
Multiple nail pops were observed in the ceiling in one or more rooms at the time of the inspection. In the inspector's opinion, nail pops may be an indicator of over-driven or under-driven nails and may decrease the service life of the drywall. This is for your information. The inspector recommends monitoring these nail pops for signs of worsening.

2nd story, bathroom ceiling, nail pop

If you are concerned the inspector recommends speaking to the builder for further evaluation and repair/ replacement by a professional contractor.

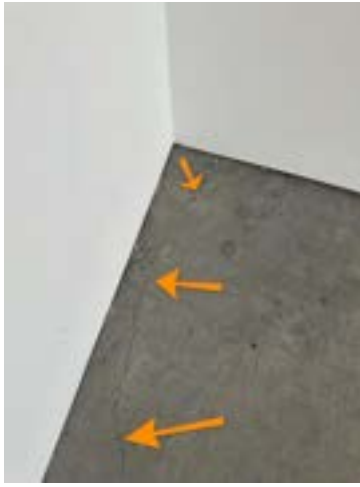
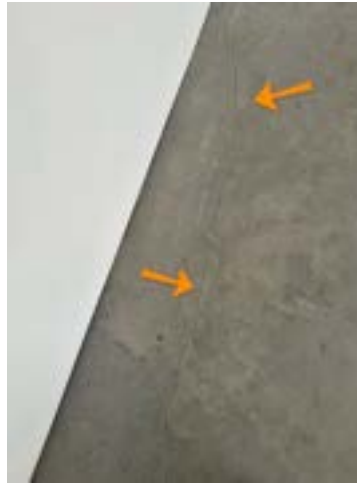
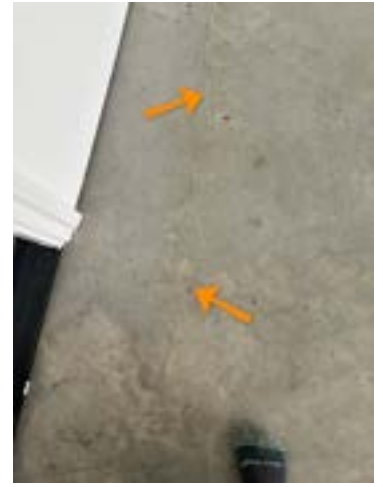
Minor cracks were observed in the garage slab at the time of the inspection. In the inspectors opinion, one of the cracks was concerning due to its location (being in the thicker portion of the slab rather than the thinner garage portion of the slab). This is for your information.

Garage, slab, minor crack

The inspector recommends monitoring the cracks for signs of movement (in width or displacement). If you notice the crack become wider than 5/8th of an inch, OR if you are concerned the inspector recommends speaking to the builder for further evaluation by a structural engineer to determine the cause and best course of action.

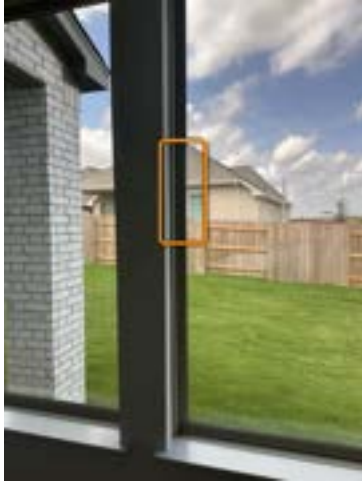
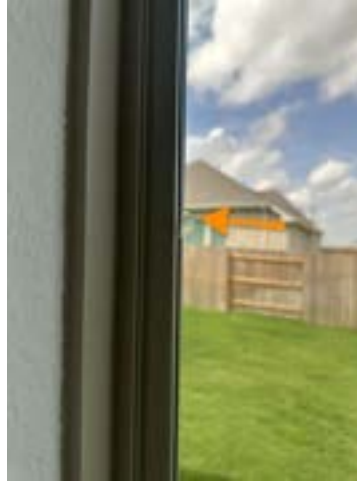
One or more cracked windows were observed at the time of the inspection.

Living room, window, cracked

The inspector recommends replacement by a professional window contractor.

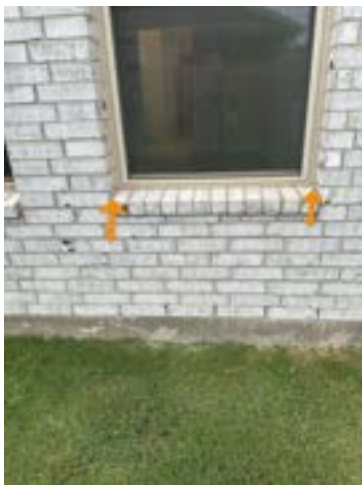
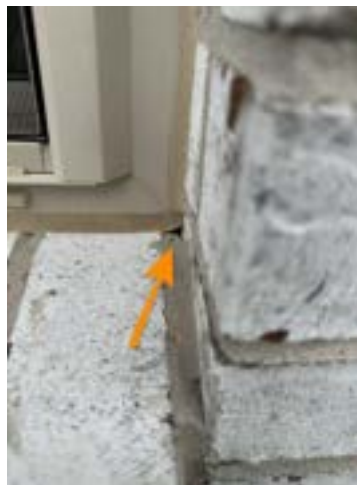
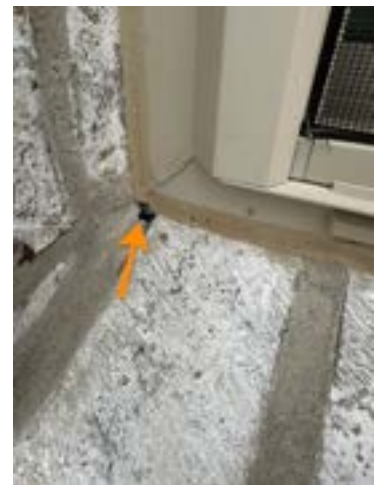
Deteriorated caulk/ sealant was observed at one or more windows at the time of the inspection. Caulk/ sealant is not a permanent seal.

Back of home, windows, caulk/ sealant, deteriorated

The inspector recommends checking all exterior and interior locations with sealant/ caulk at least once a year as part of routine maintenance to protect from moisture intrusion.

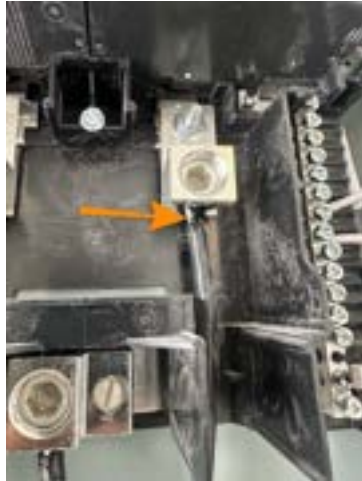
Exposed solid aluminum wiring was observed at the main service lugs at the time of the inspection. Solid aluminum wiring should not be exposed due to its high potential for corrosion and should have anti-corrosive sealant or cap for protection. This is for

Sub panel, solid aluminum cables,  
exposed

The inspector recommends further evaluation and correction by a qualified electrician.

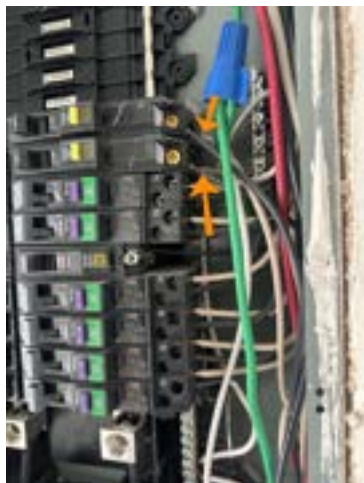
Sub panelboard, circuit breakers,  
double tapped neutrals

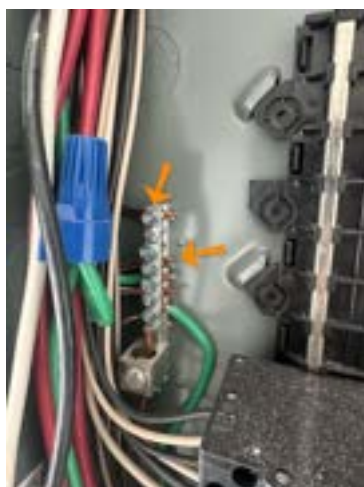
Double taps were observed at the neutral bus bar in the sub panel board at the time of the inspection. This may cause overheating.

Sub panelboard, neutral bus bar,  
double tapped

The inspector recommends further evaluation by licensed electrician to determine if the enclosure allows double taps at the neutral bus bar.

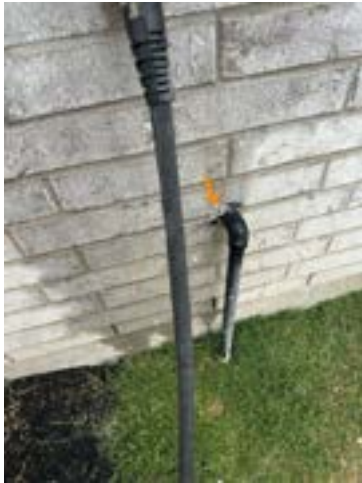
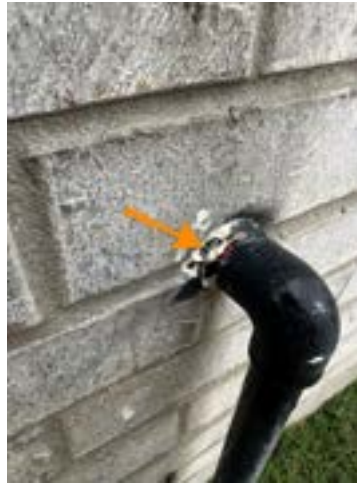
One or more loose exterior outlets were observed at the time of the inspection. There was also disconnected conduit at these outlets at the time of the inspection. All exterior electrical must be enclosed in the appropriate conduit to protect from the exterior elements. This is for your information.

Left of home, electrical conduit, loose

The inspector recommends a qualified professional correct the outlets.

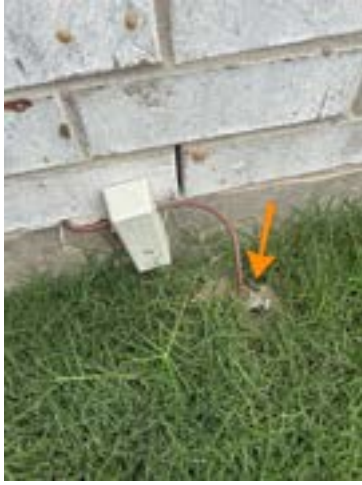
Left of home, grounding rod & wire connection, exposed

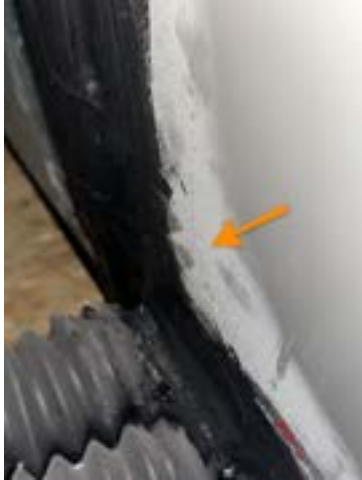
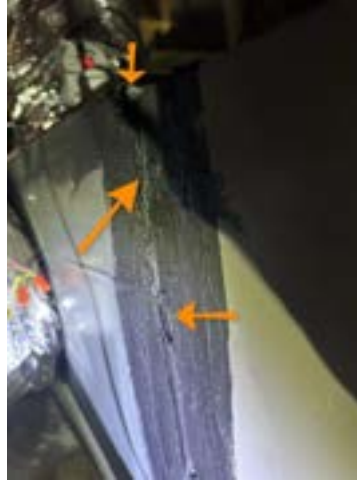
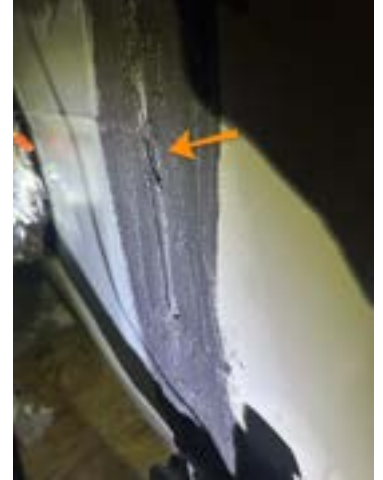
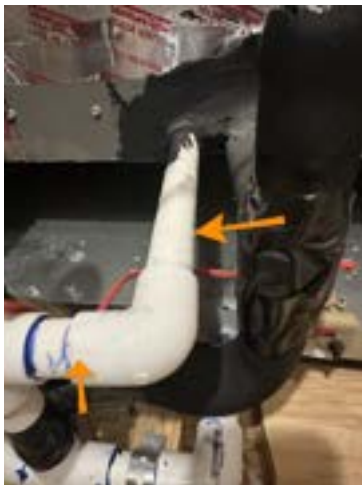
Attic, HVAC unit, condensation

Attic, HVAC unit, openings & condensation

correction by a qualified HVAC technician.

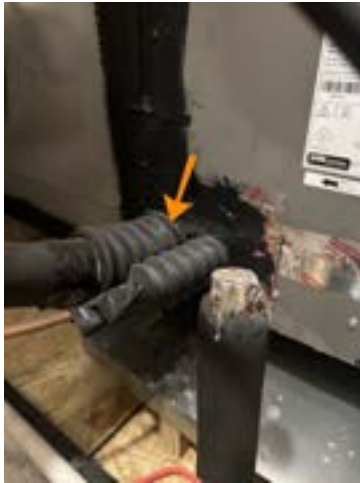
Attic, furnace, flex pipe

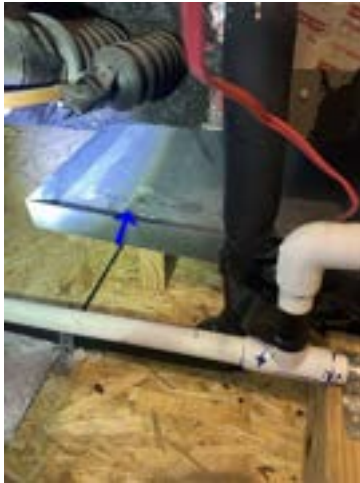
Attic, HVAC unit, drip pan,  
moisture stains

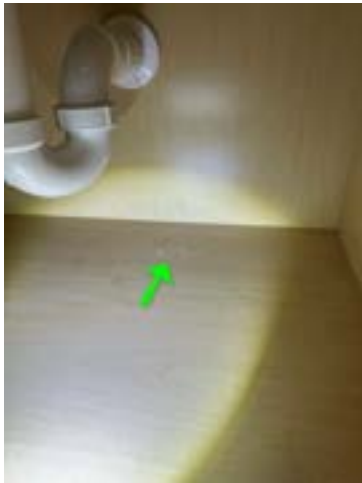
Moisture stains were observed at the under- sink cabinet at the time of the inspection.

No active leaks were observed in this area at the time of the inspection. The inspector is unable to determine the cause or when this occurred. This is for your information.

2nd story, sink cabinet, moisture stains, no active leaks

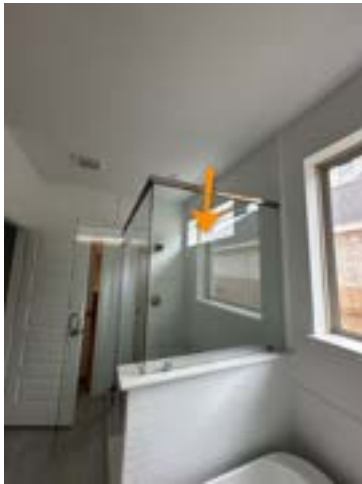
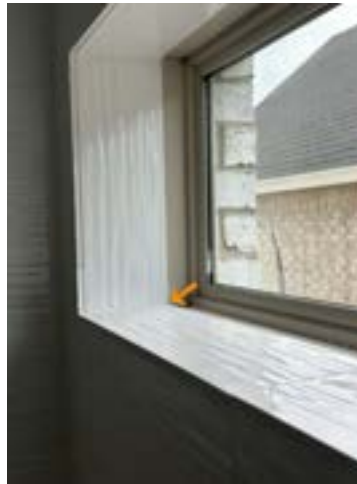
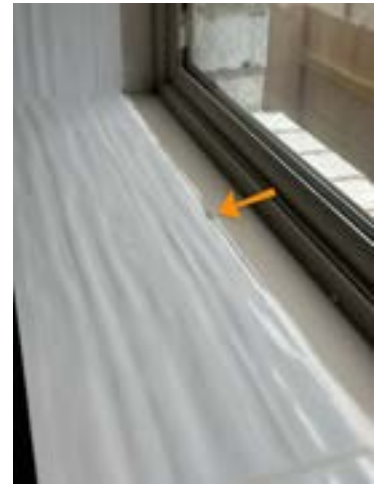
A minor separation was observed in the bathroom shower tile wall's mortar at the time of the inspection. In the inspectors opinion, these areas are more prone to moisture intrusion. There should be no separation or openings in the mortar or areas with sealant/ caulk. This is for your information.

Master bathroom, window above shower, mortar separated

The inspector recommends applying new mortar to protect from moisture intrusion.
