## HOME INSPECTION REPORT

123 Sample Street, Demo City, ST 12345

InterNachi Certified Professional  
Inspector - Lic. #HI13583  
(941) 444-2080  
[office@integrityhomeinspectionsfl.com](mailto:office@integrityhomeinspectionsfl.com)

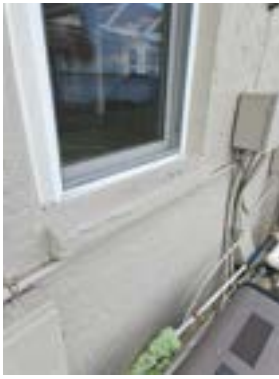
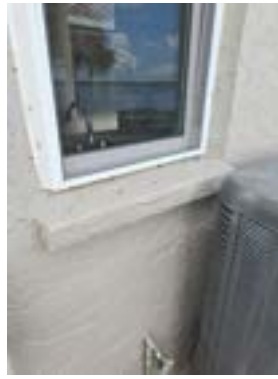
Siding - Worn

Observed damage and deterioration on the trim/siding of the exterior wall. Possible causes include weathering or physical impact. Repair/replace as needed.

Location: Rear

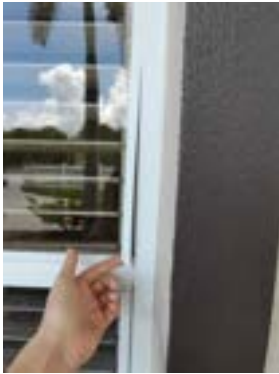
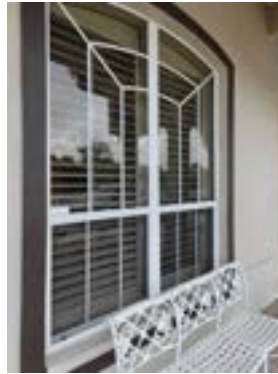
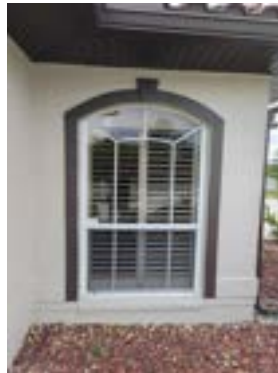
**Location:** Front windows

### Window Trim - Loose

Loose trim was observed around one or more windows at the exterior. Repair or secure the loose trim to help maintain a proper weather-resistant seal. A qualified contractor should correct this condition as needed.

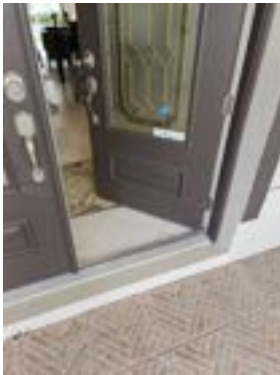
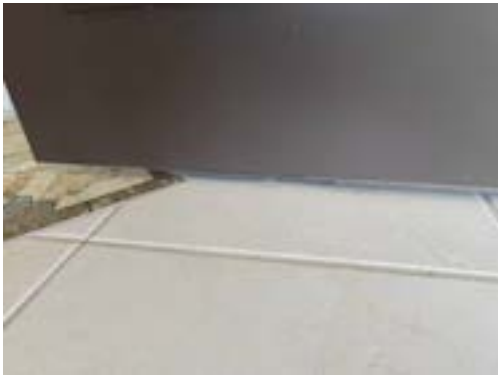
### Weather Stripping - Worn

Worn weather stripping was observed at an exterior door or window. This can allow air and moisture intrusion, and replacement or repair is recommended to help maintain a proper seal.

**Location:** Front door

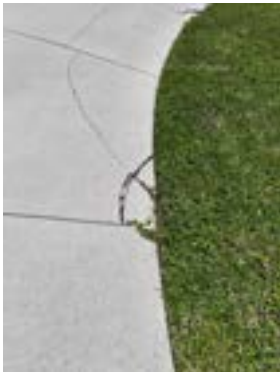
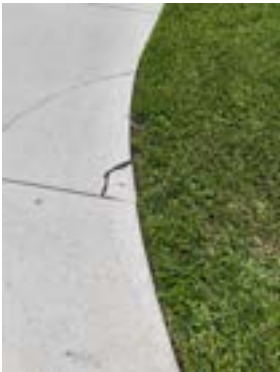
Cracking was observed in the driveway surface. This condition may allow further deterioration, create uneven areas, and increase trip or vehicle-related wear concerns. Have the driveway evaluated and repaired by a qualified contractor to help prevent continued damage and improve safety.

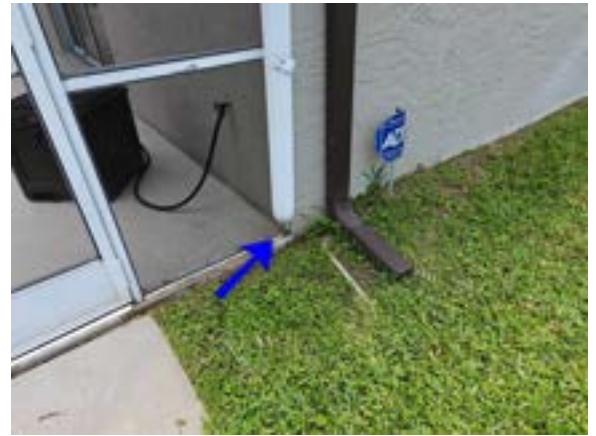
#### Gutter Downspout Extension missing

The gutter downspout lacks an extension at the termination point. The absence of a downspout extension may result in concentrated water discharge near the foundation, potentially leading to soil erosion. Consider installing a downspout extension to direct water away from the foundation. This may help to prevent water damage to the foundation or surrounding areas.

**Location:** Back left corner

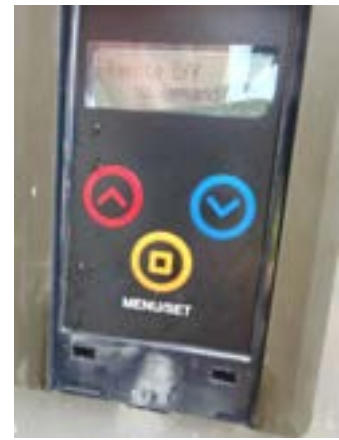
### Not Tested

The pool heater was not tested. This unit has a code pop up indicating a wireless remote is used to control the unit. Recommend obtaining this from the homeowner.

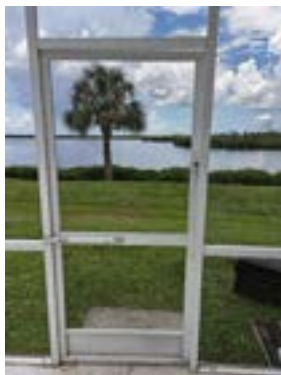
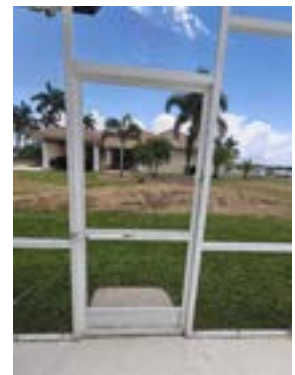
#### 4.11 Safety Devices

The screen door was observed to not self-latch when closed. This condition may reduce the effectiveness of the barrier and can allow unintended access to the pool area. Proper self-latching is an important pool safety feature. I recommend repair or adjustment of the door latch so it closes and latches properly.

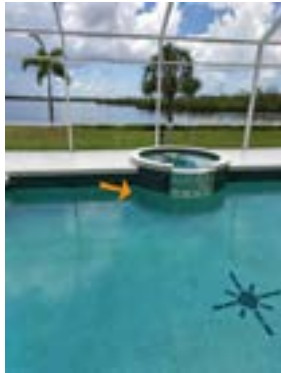
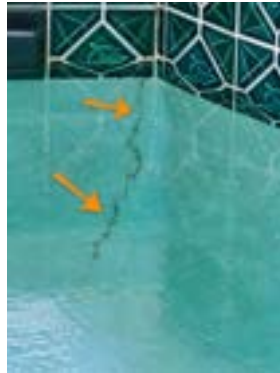
**Surface Crack**

A surface crack was observed in the pool finish. This condition can allow water intrusion behind the surface and may lead to further deterioration over time. The crack should be evaluated and repaired as needed to help maintain the pool surface and reduce the chance of continued damage.

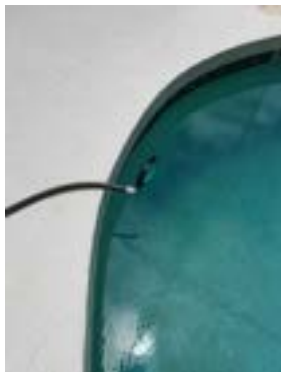
**Loose**

The pool light appeared loose at the time of inspection. A loose light can allow movement at the fixture and may affect proper sealing or secure attachment. This condition should be corrected to help maintain safe and reliable operation. I recommend repair by a qualified contractor.

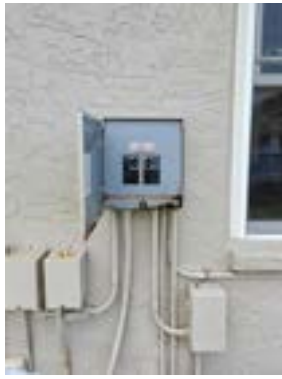
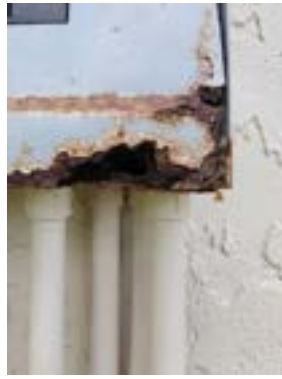
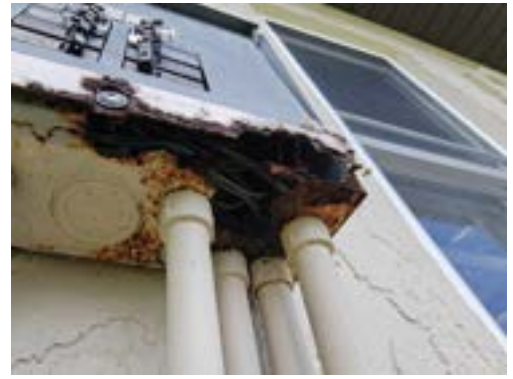
**Sub Panel - Rusted**

Rust was observed on the sub panel. Corrosion can affect panel components and may indicate moisture exposure, so evaluation and repair by a qualified electrician is recommended.

**Location:** Rear

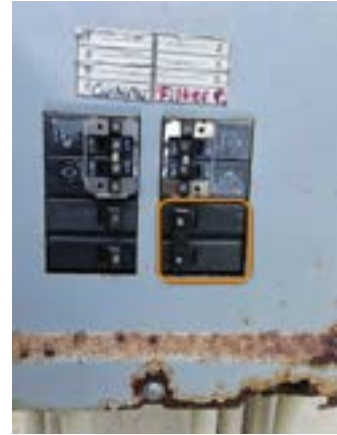
### Pool Equipment - No GFCI

GFCI protection was not identified for the pool equipment circuit during the inspection. Recommend evaluation by a qualified electrician.

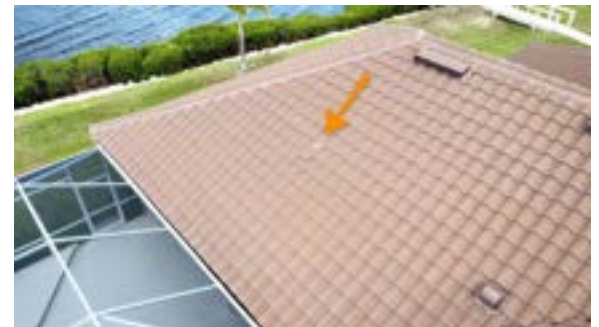
**Tiles Cracked/Broken**

Cracked and/or broken roof tiles were observed at the time of inspection. Damaged tiles can allow water intrusion and may lead to leakage or deterioration of underlying roof materials. I recommend repair or replacement of the affected tiles by a qualified roofing professional. Corrections should be made to help maintain the roof covering and reduce the potential for moisture-related damage.

**Location:** Rear

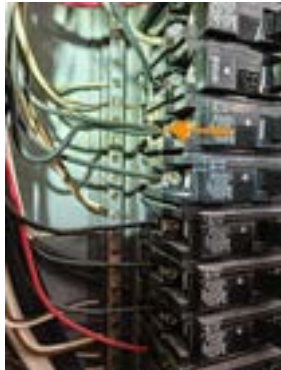
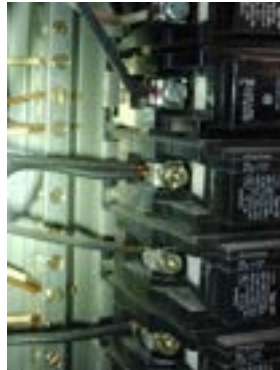
**Location:** Left panel

Observed one or more double-tapped conductors at the circuit breaker. Two conductors are connected to a single terminal. This configuration can result from modifications or additions to the electrical system without proper planning. Unless specifically listed by the breaker manufacturer for multiple conductors. Recommend evaluation by a qualified electrician to determine if the breaker is rated for multiple conductors and to correct the wiring as needed.

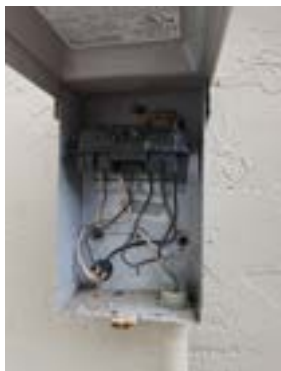
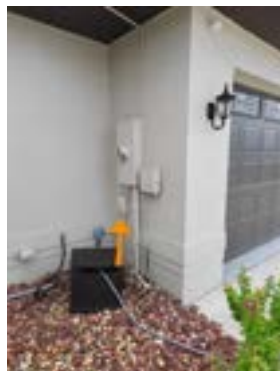
**Location:** By garage

**Missing Disconnect Cover**

The cover was missing at the electrical disconnect at the time of inspection. This leaves energized components more accessible and can allow dirt, moisture, or accidental contact at the disconnect. I recommend having a qualified electrical contractor install the proper cover to help restore safe protection for this equipment.

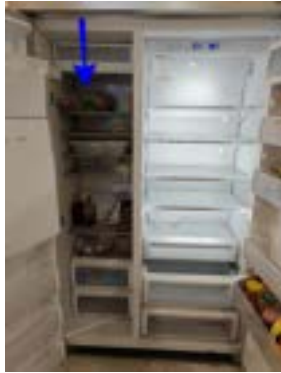
A light fixture was observed to be inoperable at the time of the inspection. This may indicate a failed bulb, fixture component, switch issue, or another electrical problem, and the fixture may not function as intended. Repair or further evaluation by a qualified electrical contractor is recommended.

**Location:** Freezer, lanai

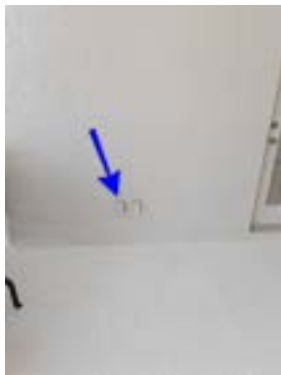
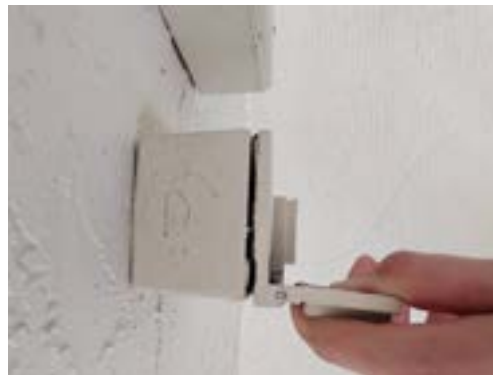
A receptacle was observed to be loose at its mounting location. Loose receptacles can shift during use, which may lead to damaged wiring connections or unreliable operation. I recommend having this receptacle secured and repaired by a qualified electrician. Correction will help improve safety and proper function.

**Location:** Lanai

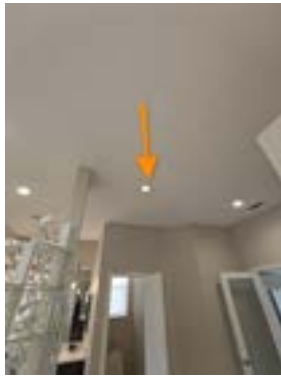
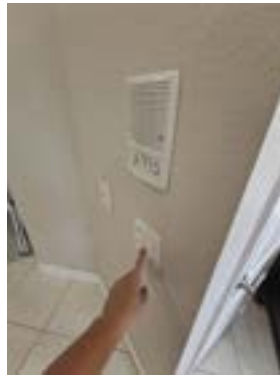
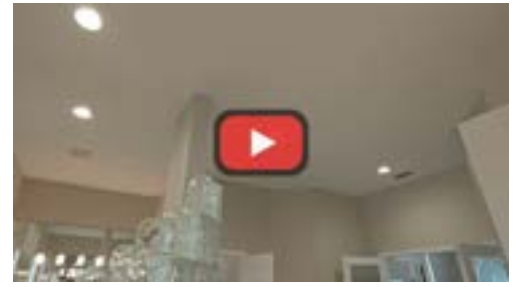
A dimmer-controlled light was observed surging during operation. This may indicate a problem with the dimmer, bulb compatibility, or the fixture. Repair or replacement by a qualified electrician is recommended.

**Location:** Master bathroom

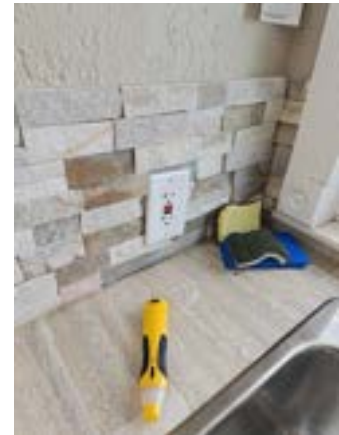
One or more GFCI outlets were tripping under load. This condition may leave the outlet without proper ground-fault protection or may indicate the outlet is not functioning correctly. This is a safety concern, especially in areas where moisture may be present. I recommend repair or replacement by a qualified electrical contractor.

**Location:** Outdoor Bar

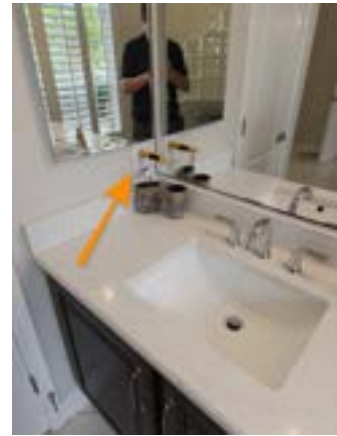
**Location:** Master bathroom

A receptacle was tripped and the reset location could not be identified at the time of inspection. This should be evaluated and corrected by a qualified electrician to restore proper operation and confirm the circuit is functioning safely.

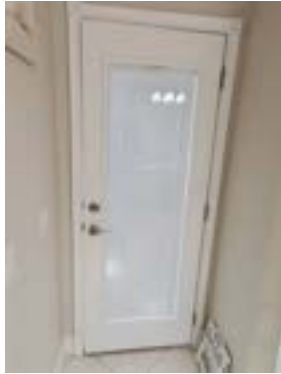
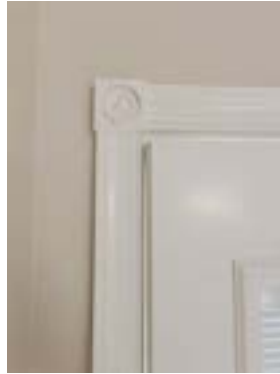
The door was rubbing against the door frame along the top edge. This may be due to normal settling of the house, changes in humidity, loose hinges, or an improperly installed door frame. Adjusting the strike plate, tightening hinge screws, or shimming the hinges may resolve the issue. If the problem persists, recommend evaluation by a qualified carpenter.

**Location:** Bathroom by kitchen

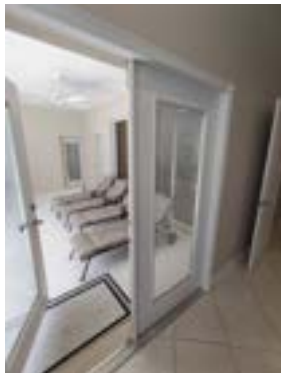
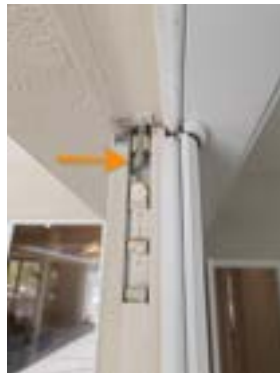
**Door - Damaged Stationary Pin**

The stationary pin at the door was observed to be damaged. This can affect proper operation and security, and repair or replacement by a qualified contractor is recommended.

**Location:** Office

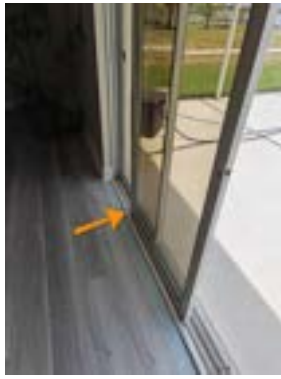
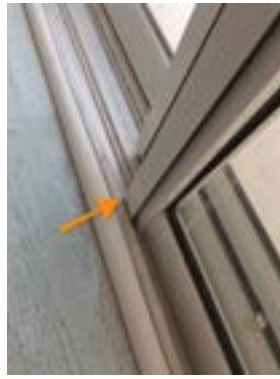
**Door - Damaged Floor Track**

The door floor track was observed to be damaged. This can affect smooth operation and proper alignment of the door; repair or replacement by a qualified contractor is recommended.

**Location:** Master bedroom

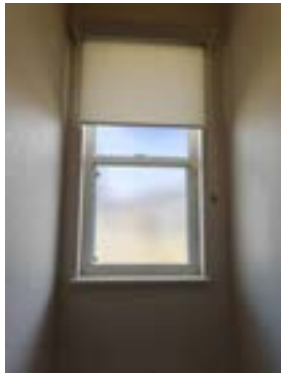
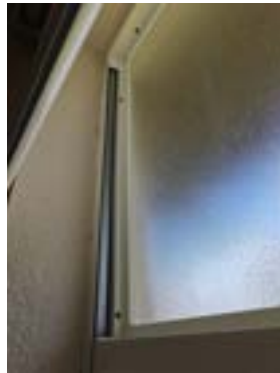
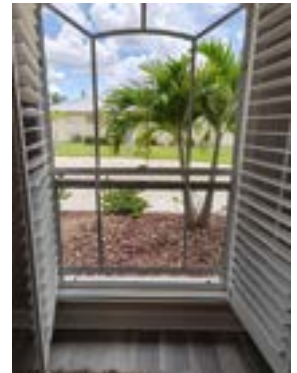
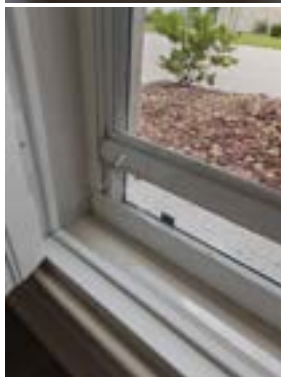
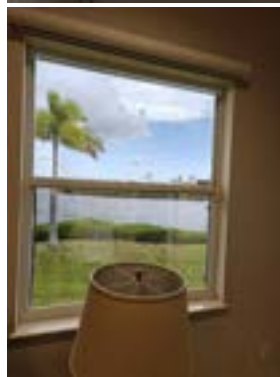
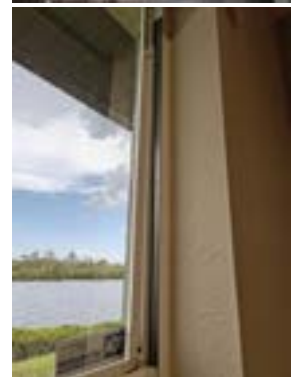
### Broken/Loose Balance

The window balance is detached from its track. The balance coil is visible and no longer providing tension to assist with window operation. The balance may have detached due to age, wear, or damage to the attachment points. Recommend evaluation and repair or replacement of the window balance by a qualified window specialist.

**Location:** Master bathroom, front windows

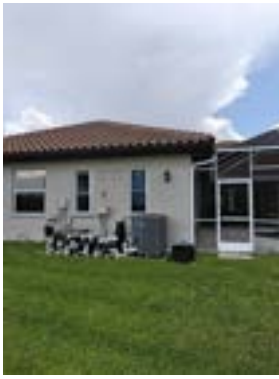
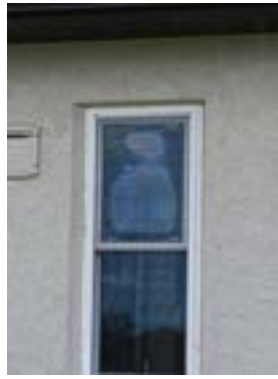
### Failed Seal

One or more window panes show clouding and reduced visibility, which is an indication of seal failure. Window seal failure is often caused by age, thermal stress, and exposure to the elements, leading to condensation between the panes. This leads to poor energy efficiency. Consider replacing the affected windows or contacting a window repair specialist for seal replacement.

**Location:** Back window

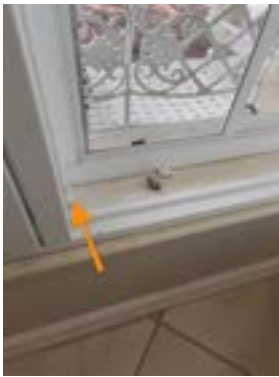
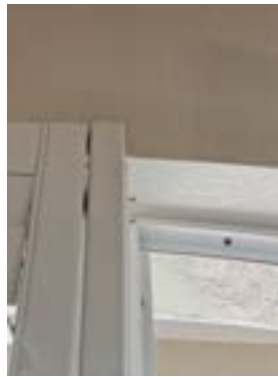
#### Plantation Shutters - Damaged Magnets

Damaged magnets were observed on the plantation shutters. This can prevent the shutters from staying properly closed or aligned, and repair or replacement of the affected magnets is recommended.

**Location:** Most windows

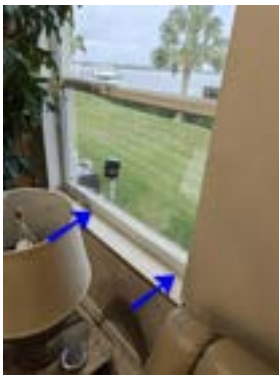
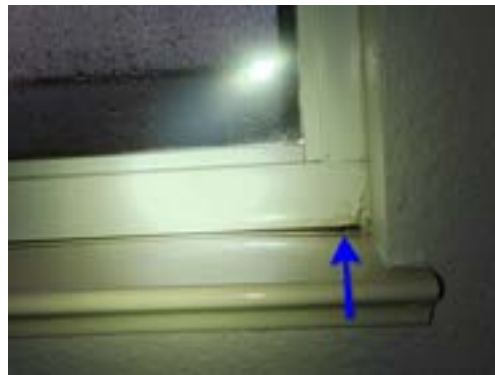
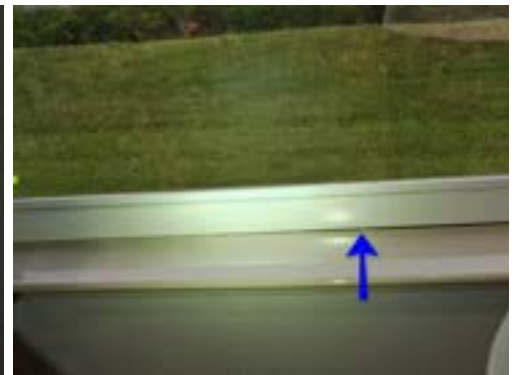
#### Window - Gap Sealant Needed

Gaps were observed at window sealant areas, and additional sealing is needed. This can allow air and moisture intrusion; have the gaps properly sealed to help maintain energy efficiency and reduce the chance of moisture-related damage.

**Location:** Living room window

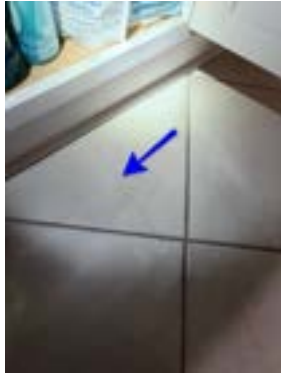
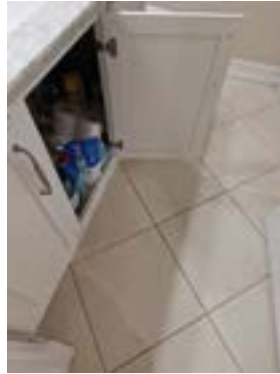
**Hairline Cracks**

Hairline cracks are observed in some of the floor tiles. Cracks may be due to settling, improper installation, or lack of support beneath the tiles. Monitor the cracks for changes. Consider consulting a qualified flooring contractor to evaluate the cause and recommend appropriate repairs.

**Location:** Bathroom by kitchen

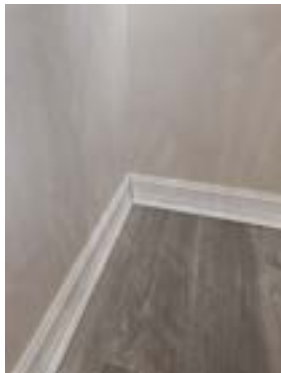
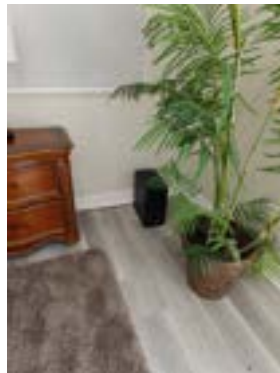
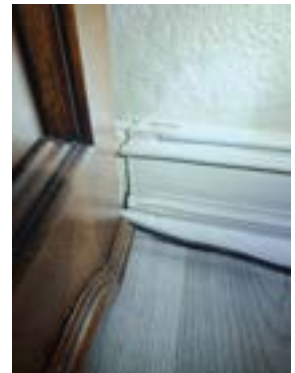
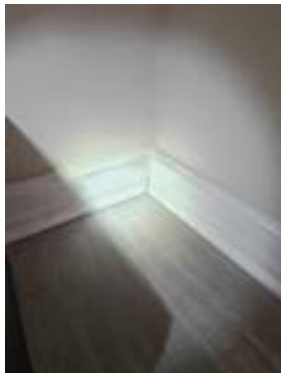
**Baseboards/Trim - Separated**

The baseboard was observed separated from the wall/floor in one or more areas. This can be a sign of movement, minor damage, or loose attachment. There was no moisture detected at the time of inspection. Underlying conditions unknown.

**Location:** Master bedroom

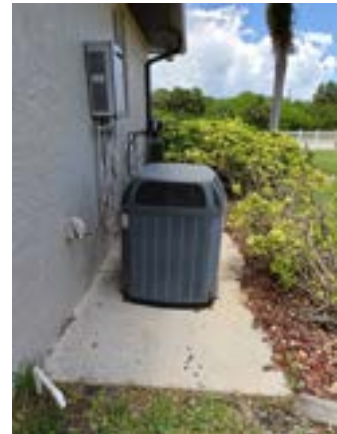
The cooling/heating equipment was observed to be unusually noisy during operation. Excessive noise can indicate wear, loose components, or other mechanical issues that may affect performance over time. I recommend having the unit evaluated and serviced by a qualified HVAC contractor. Repairs or maintenance should be made as needed to help ensure proper operation.

**Location:** Left side

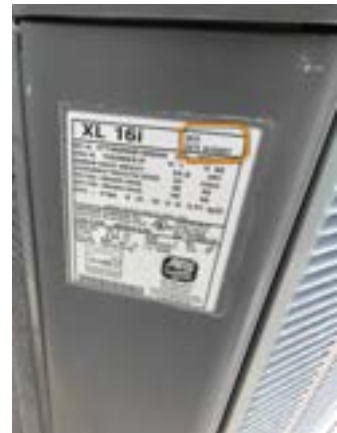
##### **End of Expected Service Life**

The master bedroom HVAC system is at or near the end of their expected service life. Components in this condition may continue to function for a period of time, but reliability is reduced and failure can occur without much warning. This can affect normal operation and may lead to loss of heating or cooling control. I recommend budgeting for replacement and having the controls evaluated by a qualified HVAC contractor.

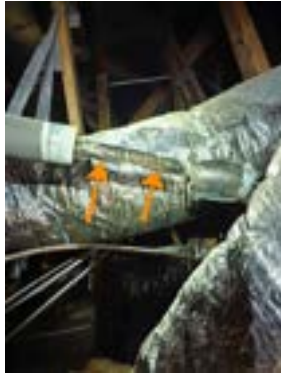
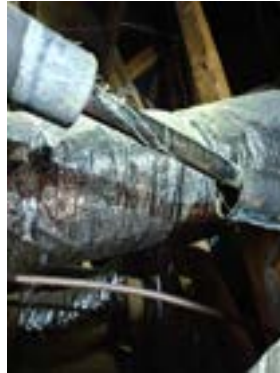
**Poor Insulation Wrap**

Poor insulation wrap was observed at the HVAC distribution system. Inadequate or damaged insulation can reduce energy efficiency and may allow condensation to form on the duct surface. Repair or replacement of the affected insulation wrap is recommended to help improve system performance and reduce the potential for moisture-related issues.

**Location:** Above master closet attic access

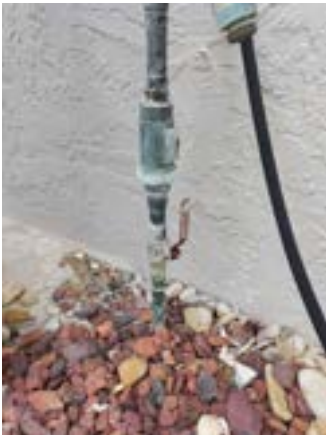
Location: Left side of home

The main water shut-off valve was observed and appeared accessible at the time of inspection.

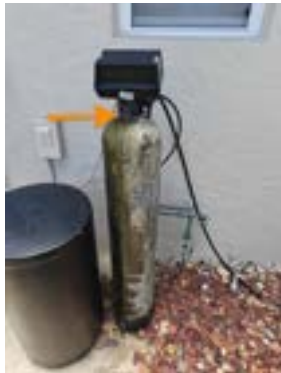
A leak was observed at the filter. This can lead to water damage and may affect system performance; repair or replacement by a qualified plumber is recommended.

**Location:** Left side of home

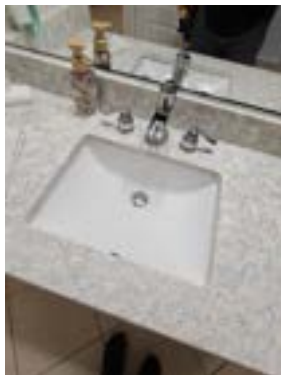
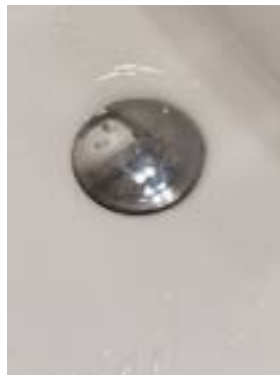
**Sink Stopper - Stuck Down**

The sink stopper did not pop back up when operated, which can interfere with normal drainage and use of the fixture. Repair or adjustment by a qualified plumber is recommended.

**Location:** Bathroom by kitchen

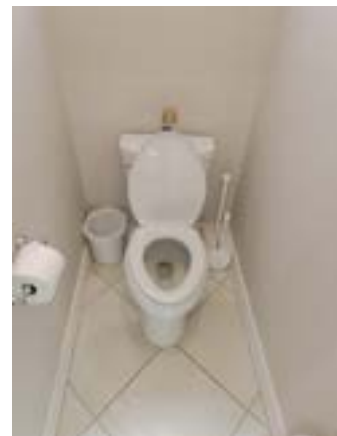
11.19 Water Supply, Distribution  
Systems & Fixtures

The toilet exhibits movement at the base. Possible causes include loose mounting bolts, deteriorated wax ring, or underlying floor damage. Recommend a qualified plumber inspect and repair the toilet mounting and seal to prevent potential leaks and further damage.

**Location:** Master bathroom

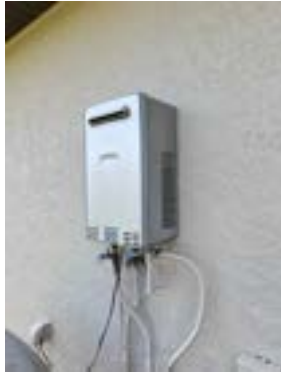
**Near End of Life**

The tankless water heater appears to be near the end of its typical service life based on its age. Older units are more likely to develop leaks, reduced efficiency, or other performance issues as components wear over time. While the unit may be operating at the time of inspection, budgeting for replacement in the near term is recommended. A qualified plumbing contractor should repair or replace the unit as needed.

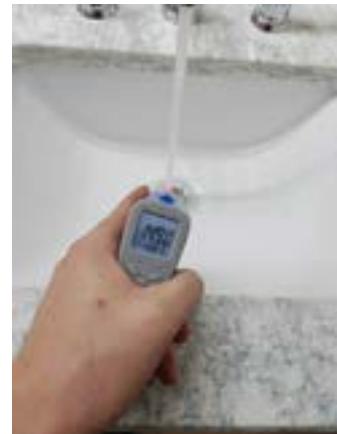
11.21 Hot Water Systems,  
Controls, Flues & Vents**High Temperature**

The water heater was observed to be set at a high temperature at the time of inspection. Water that is too hot can increase the risk of scalding and may also place added stress on the system. I recommend having the temperature setting adjusted to a safe range and monitoring performance afterward.

**Location:** Garage Water heater

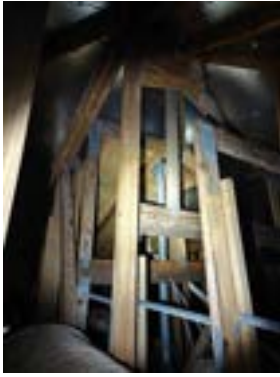
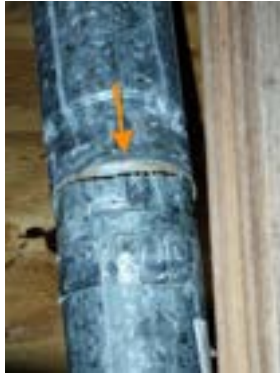
The water heater vent was observed to be loose at the time of inspection. This condition should be repaired and properly secured by a qualified contractor. Corrections are recommended to help the vent operate as intended.

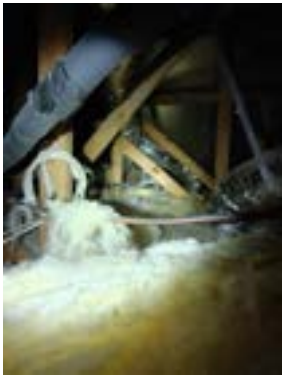
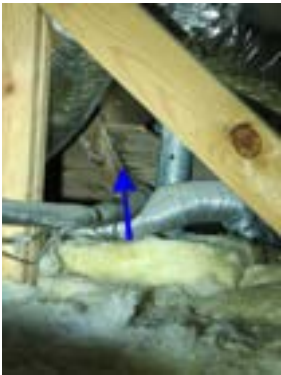
There was water staining along the roof decking in the attic. There was no moisture at the time of inspection and this appears to be as a result of a previous roof leak. Recommend monitoring this condition.

Location: Far left side of home
