## MOLD ASSESSMENT REPORT

123 Sample Street, Demo City, ST 12345

##### Limited Mold Inspection

##### Room/Area of Concern: Reception/Office

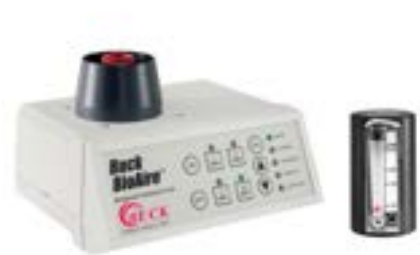
Buck BioAire - Bioaerosol Sampling Pump

Several mold specific tools are used to complete a thorough mold assessment. In most cases each of these tools are used to preform your assessment. Rarely is it not required to use these for an assessment. These are the tools we chose to use for your assessment.

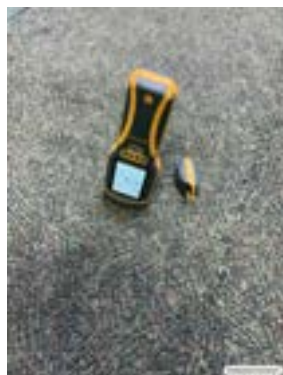
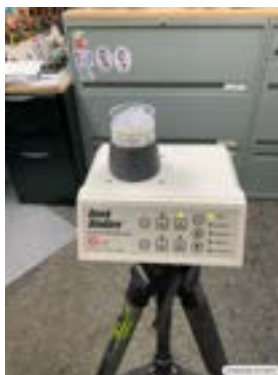
##### Moisture Meter Readings of Affected/Suspected Area(s)

The EPA recommends that lumber moisture content be  $\leq 18\%$ . The industry standard for acceptable moisture content in wood framing varies depending on the location, but typically, the number is somewhere between 9 and 14%. The acceptable moisture levels of wood and lumber range from 6% to 8% for interior and 9% to 14% for exterior wood or for building envelope components within constructed assemblies. The recommended moisture content for structural elements is 12 – 20 percent for doors and 10 – 20 percent for windows.

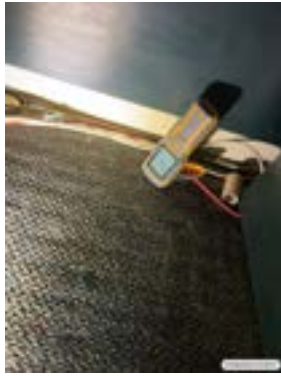
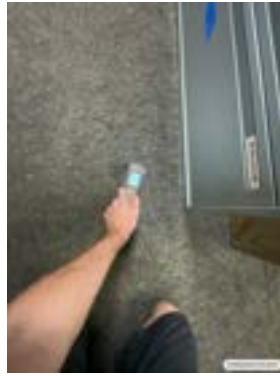
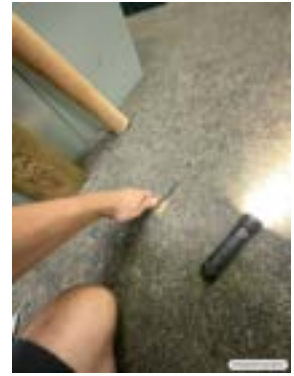
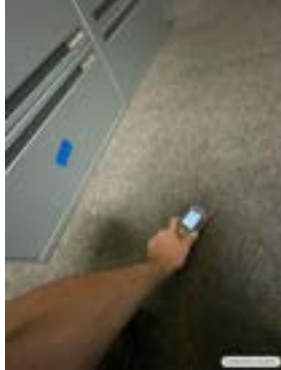
##### Relative Humidity Reading (RH)

The EPA recommends keeping indoor relative humidity (RH) below 60%, ideally between 30% and 50%. Mold and mildew can flourish in air with a relative humidity level above 50-60%. At 70% RH and above, mold formation is practically to be expected.
